February 1945 as
Advance Restricted Report E5B07

EFFECT OF PROGRESSIVE RING FAILURE ON PISTON DESTRUCTION

By Max J. Tauschek and Lester C. Corrington

Aircraft Engine Research Laboratory
Cleveland, Ohio

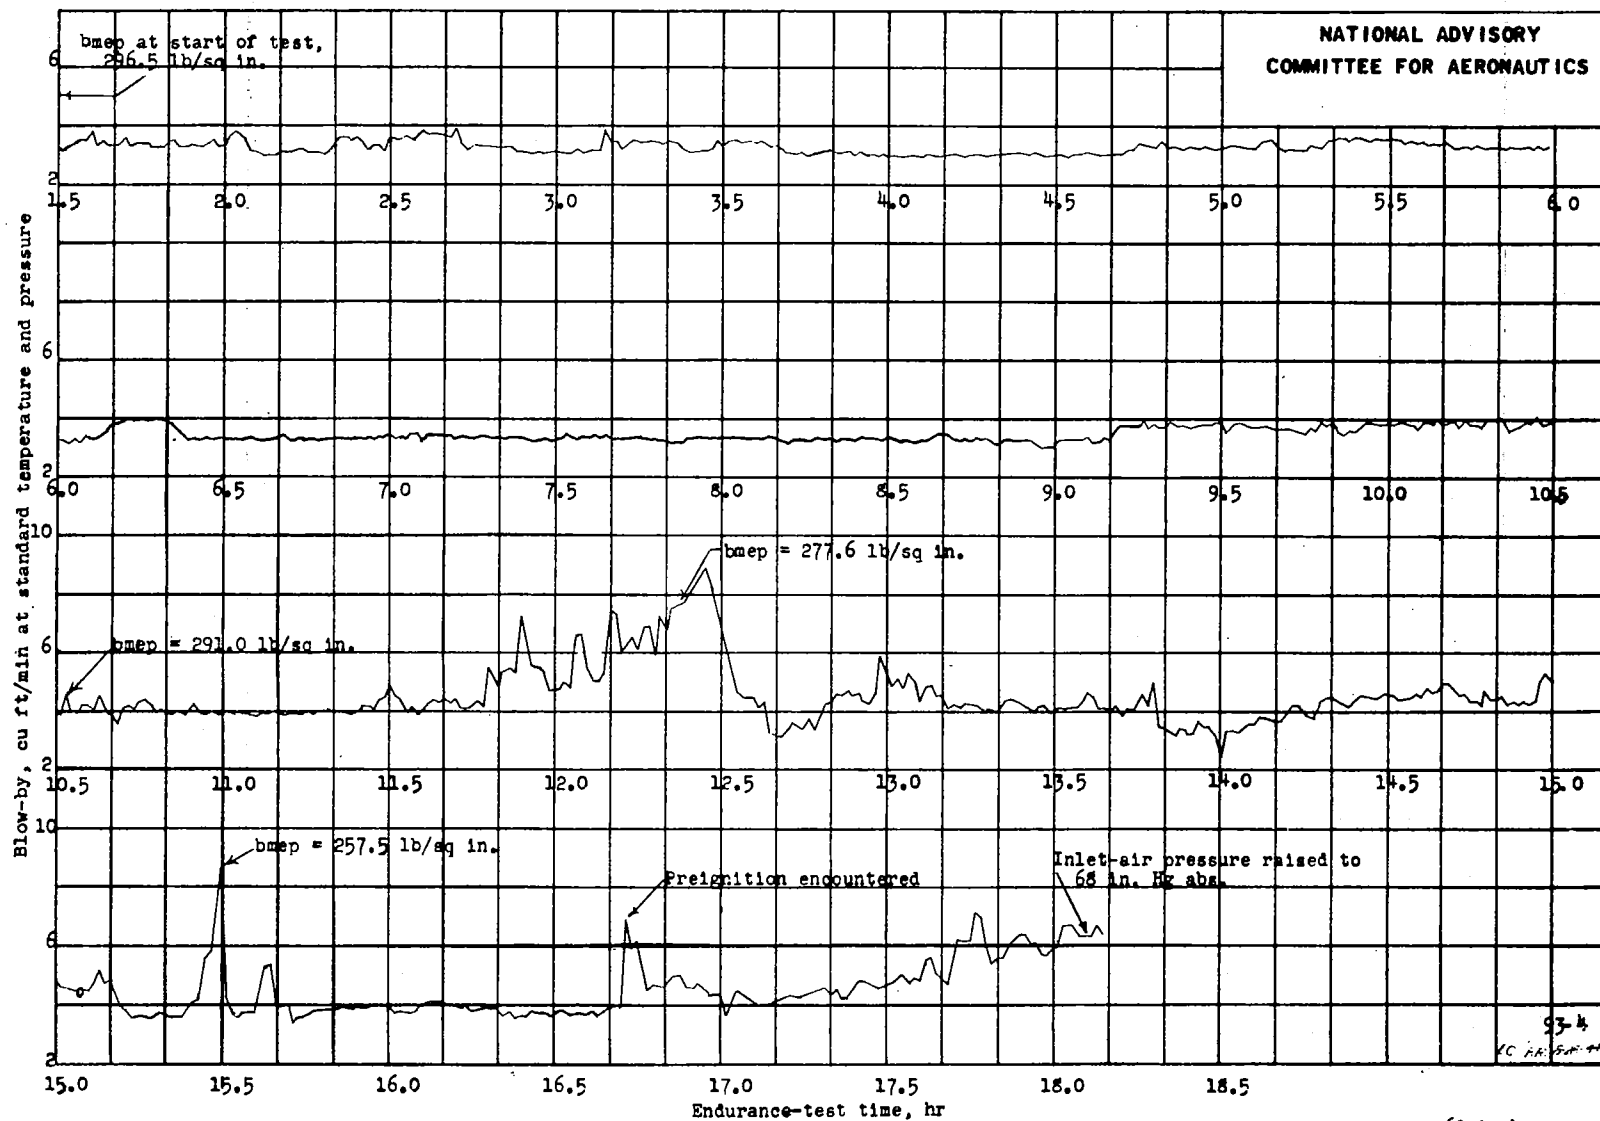
Blow-by and crankcase pressure. - The curves of the rate of blow-by and the crankcase pressure are shown in figures 4 and 5. Because the crankcase pressure is directly related to the blow-by rate, these curves are similar. It must be borne in mind, in the interpretation of the results of the crankcase-pressure curve, that the magnitudes of the crankcase-pressure values are entirely dependent upon the system used for the removal of the blow-by gases from the crankcase; a system having many restrictions, such as small piping, a flowmeter, and numerous valves, will result in high pressures, whereas a system having fewer obstructions to the gas flow will result in low pressures. The actual pressure in the crankcase was somewhat higher than the values measured because the manometer was connected to the blow-by line some distance from the crankcase.

Figures 4 and 5 indicate that, after failure of the top and second rings had taken place (beginning of endurance test), an increasing degree of failure of the compression rings did not affect the sealing qualities of the piston and ring assembly to any marked extent. The rate of blow-by and the crankcase pressure at the beginning of the test were approximately the same as those values at the

Figure 4. - Effect of running time on rate of blow-by for first endurance test. Engine speed, 2600 rpm; inlet-air pressure, 60 inches of mercury absolute (except as noted); inlet-air temperature, 100° F; fuel-air ratio, 0.095; oil flow to piston, 2.0 pounds per minute.

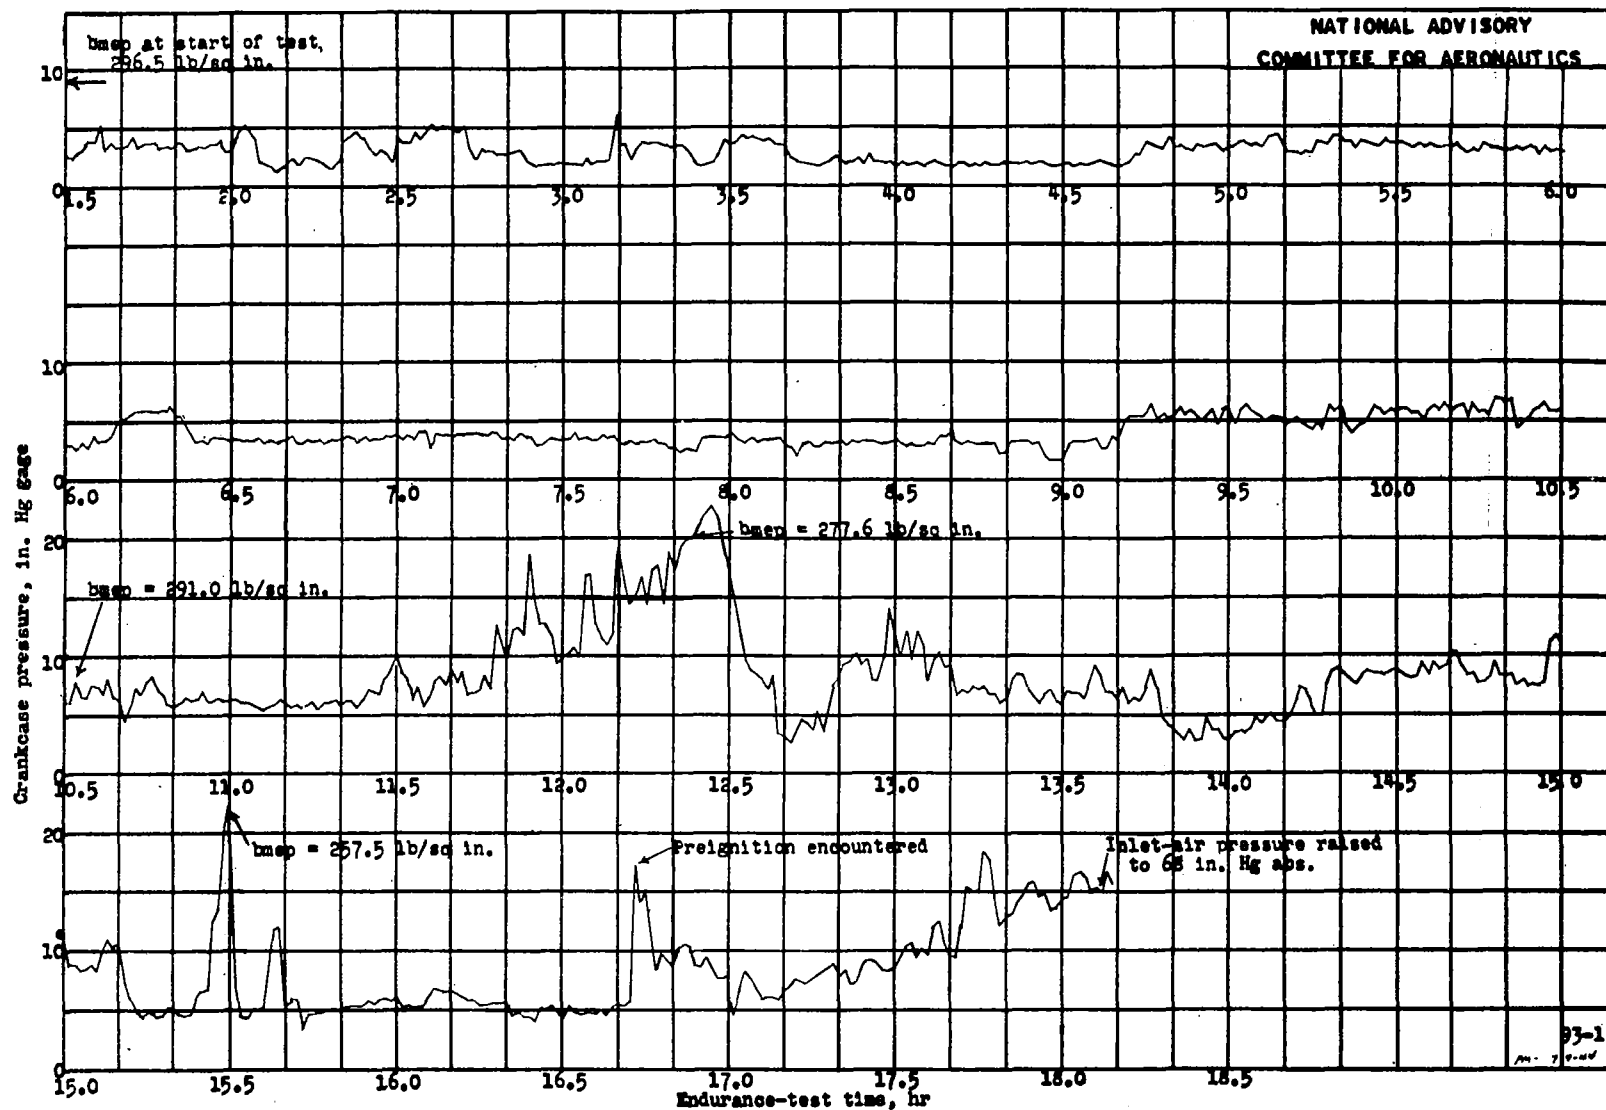
Figure 5. - Effect of running time on crankcase pressure for first endurance test. Engine speed, 2600 rpm; inlet-air pressure, 60 inches of mercury absolute (except as noted); inlet-air temperature, 100° F; fuel-air ratio, 0.095; oil flow to piston, 2.0 pounds per minute.

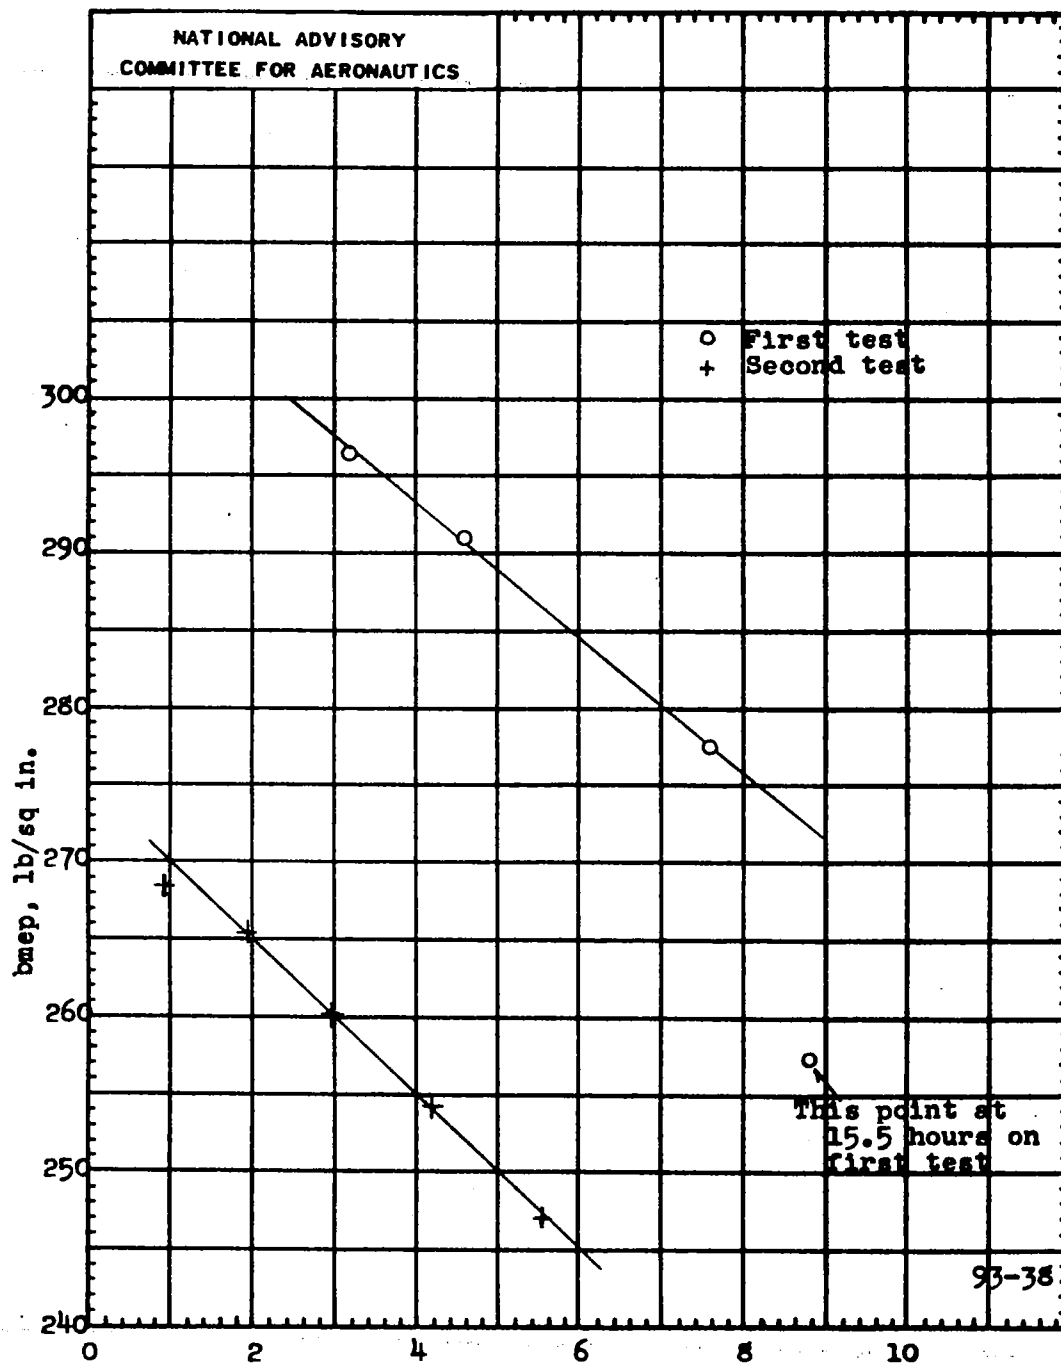
The sudden rise in rate of blow-by at 15.5 hours may also have been caused by preignition although none was detected by the time-pressure diagram on the oscilloscope. The loss in power output recorded at this point is somewhat higher than would be expected from blow-by alone (fig. 6), suggesting that preignition may have advanced only a few degrees, become stable, and shortly afterward disappeared. This type of preignition has been known to occur many times in other tests and would probably be unnoticed on the time-pressure diagram.

Blow-by, cu ft/min at standard temperature and pressure
 Figure 6. - Effect of rate of blow-by on brake mean effective pressure.
 Engine speed, 2600 rpm; inlet-air temperature, 100° F for first test,
 200° F for second test; fuel-air ratio, 0.095 for first test, 0.085
 for second test; oil flow to piston, 2.0 pounds per minute for first
 test, 0.5 pound per minute for second test.

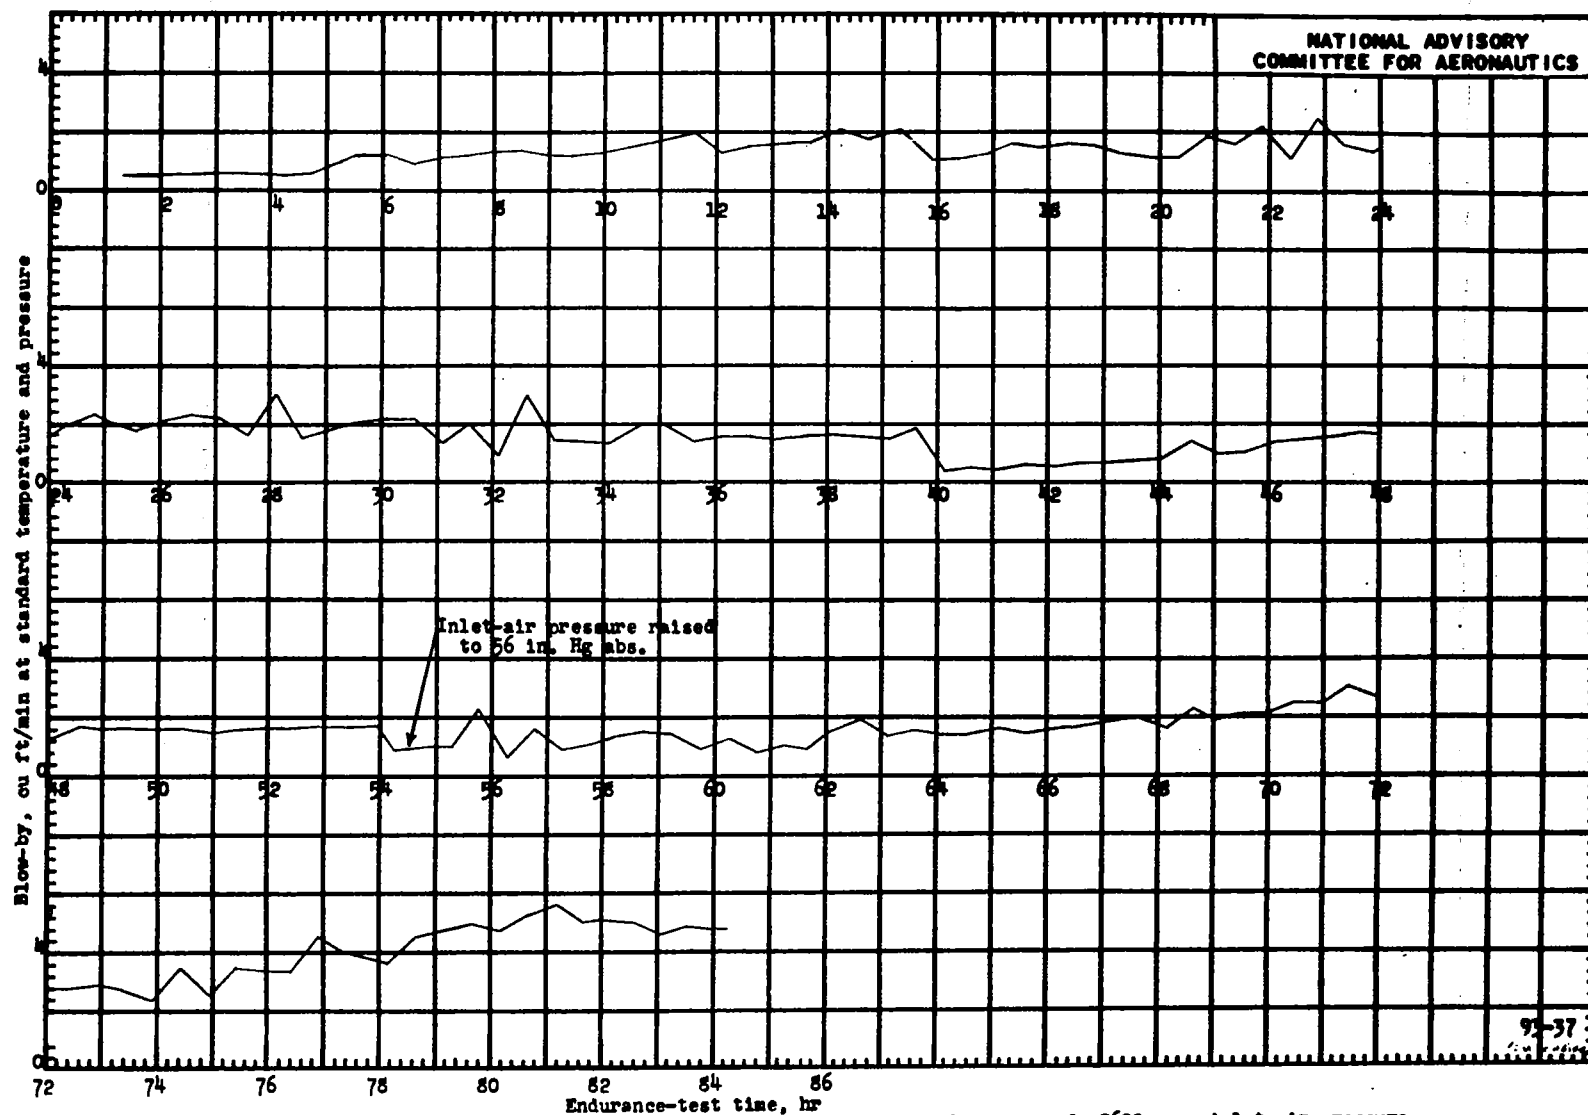
Blow-by and crankcase pressure. - The curves of rate of blow-by and crankcase pressure for the second test are shown in figures 10 and 11. These curves show a marked increase in the blow-by rate and the crankcase pressure after the first 4.5 hours of running, which indicates the beginning of compression-ring failure probably by sticking of the top ring. Unpublished data taken on this engine have shown that 0.5 cubic foot per minute is an average value for the rate of blow-by with a new piston and ring assembly when operating

Figure 10. - Effect of running time on rate of blow-by for second endurance test. Engine speed, 2600 rpm; inlet-air pressure, 50 inches of mercury absolute (except as noted); inlet-air temperature, 200° F; fuel-air ratio, 0.085; oil flow to piston, 0.5 pound per minute.

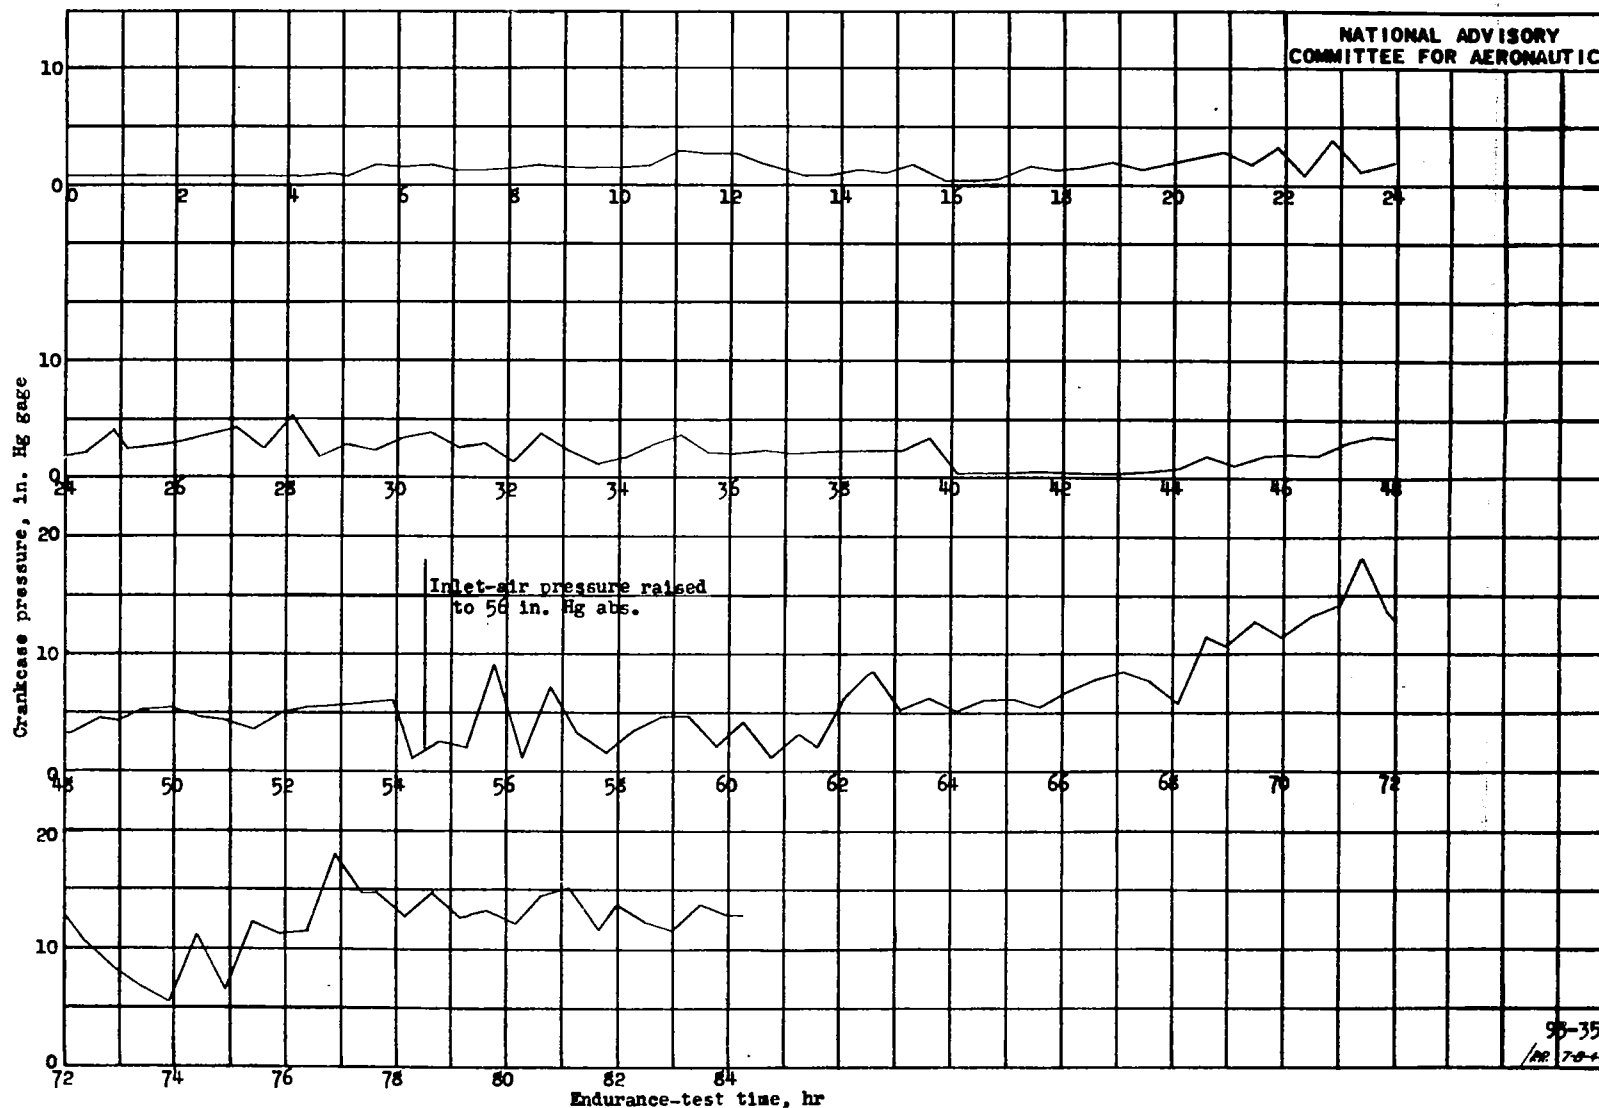
Figure 11. - Effect of running time on crankcase pressure for second endurance test. Engine speed, 2600 rpm; inlet-air pressure, 50 inches of mercury absolute (except as noted); inlet-air temperature, 200° F; fuel-air ratio, 0.085; oil flow to piston, 0.5 pound per minute.

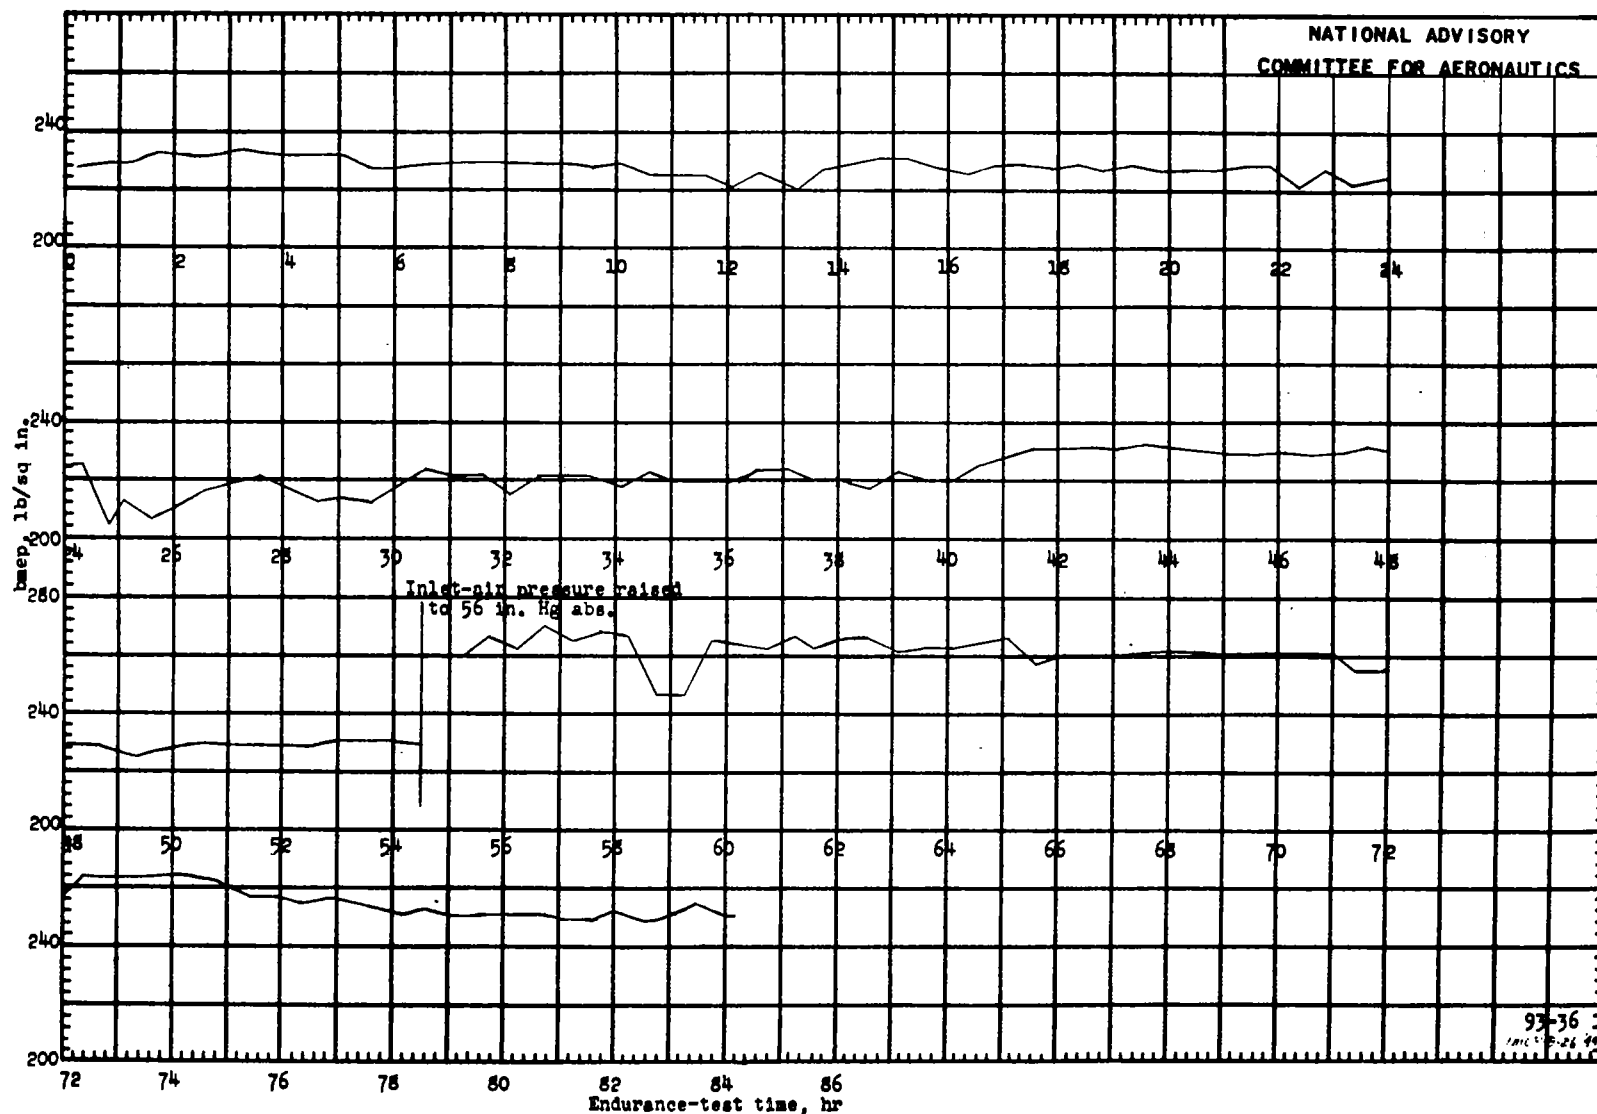
Figure 12. - Effect of running time on brake mean effective pressure for second endurance test. Engine speed, 2600 rpm; inlet-air pressure, 50 inches of mercury absolute (except as noted); inlet-air temperature, 200° F; fuel-air ratio, 0.085; oil flow to piston, 0.5 pound per minute.
